Serious Accident Investigation Tinker Bugs Prescribed Fire

September 26, 2025

Nez Perce-Clearwater National Forests

Tree Strike Fatality

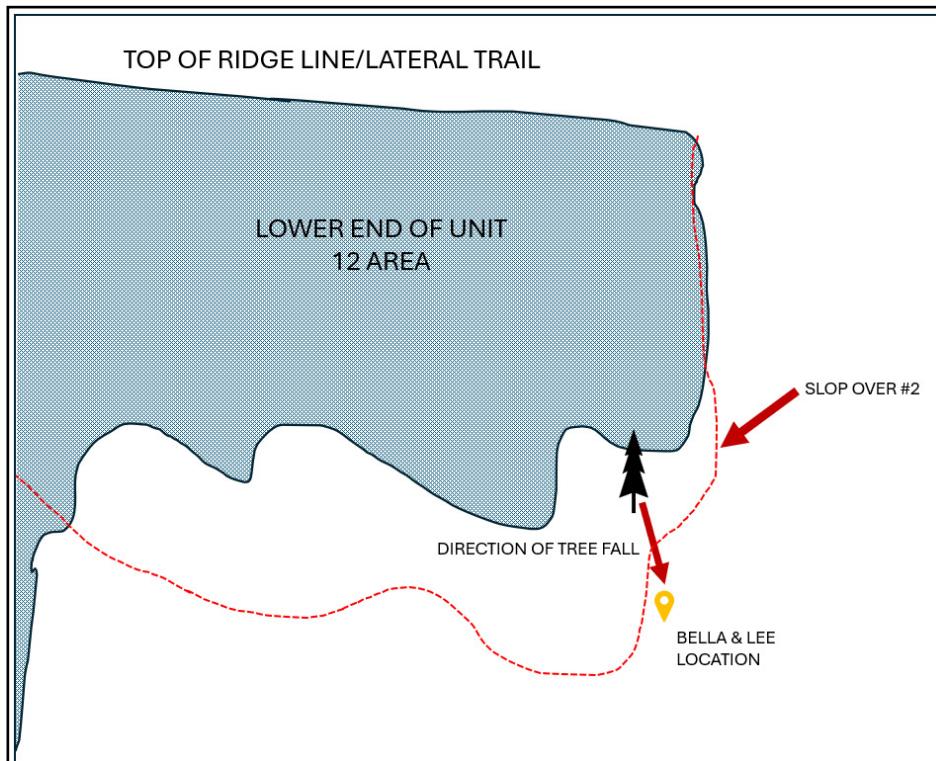
Figure 4.—Conceptual illustration of the slop-over and general accident location. Image not to scale and geography depicted meant to convey general information about accident site.

- There was no evidence of human interaction with the strike tree prior to it falling.
- The strike tree was found to be located within the slop-over, not from interior of the burn unit.

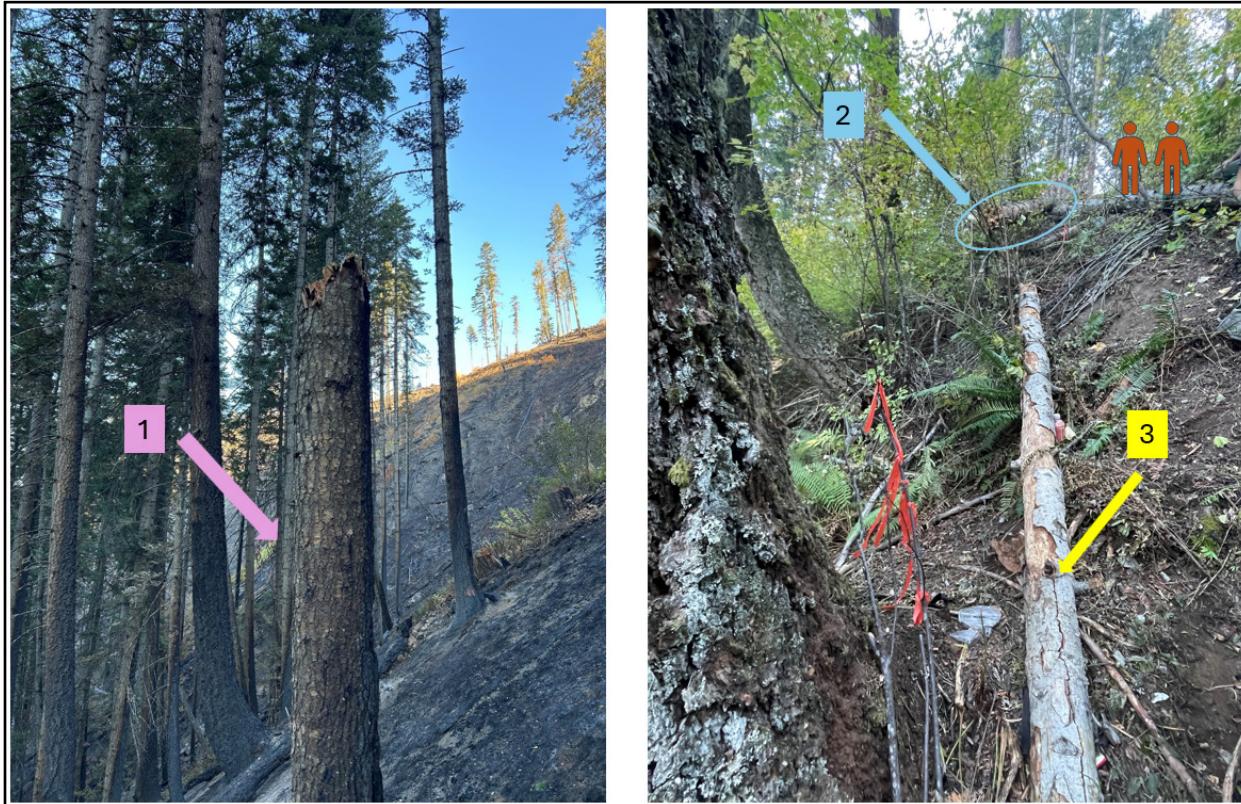
Figure 5.—Strike tree was a Grand Fir. Numbers indicate the breakage sequence: 1) tree breaks off 12 feet up the bole. 2) broken segment 2 falls into green and strikes Bella and Lee (orange icons). 3) third segment breaks off upon hitting the top of a small ledge, breaking near the fulcrum. Notice how the green brushy vegetation obscures view from above.

- The fire damage/cat's face found on the strike tree was located on the uphill and opposite side of the tree from where personnel were located. The cat face fire damage likely occurred Friday early morning after the fire rolled out of the under-slung containment line, on the lower slope.

- The location of saw repair was below a small bench type geographic feature that obscured the view of the base of the strike tree.
- The strike tree was identified as a standing, dead, Grand Fir. The diameter at breast height was approximately 15". The total tree height is estimated to be approximately 65'. At the time of examination there was evidence of decay both on the stump portion of the tree and at the location at which it broke off. There were also burn indicators present on both the stump and tree trunk. The burn indicators and loss of matter in the area where the tree broke off appear to indicate that there was damage and decay on the uphill side of the tree. The tree was broken off at approximately 12 feet above ground level.

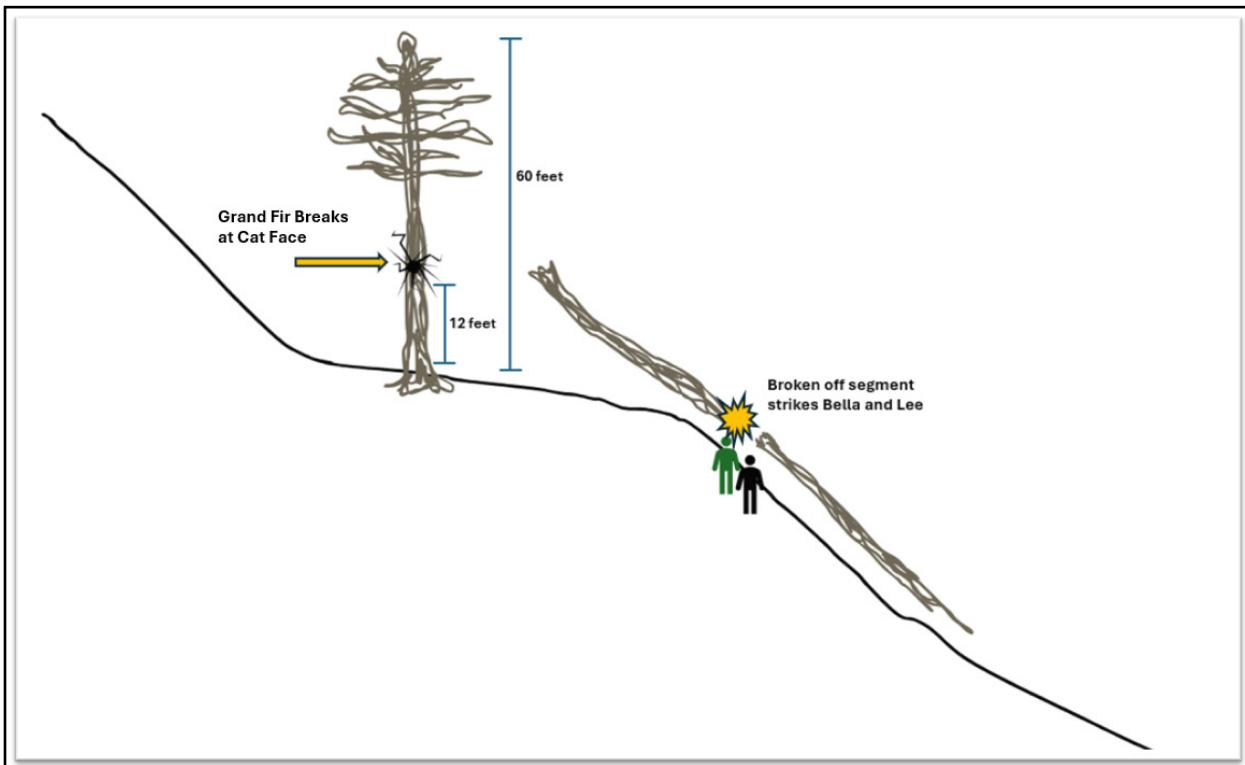
Figure 6.—Alternative view of strike tree progression. Note that Bella and Lee were downslope, below a small bench when the tree struck them.

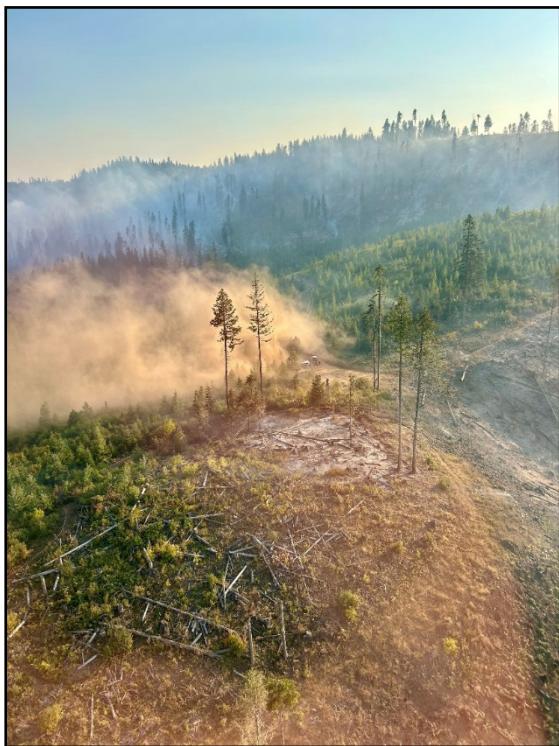
Figure 10.—Brown-out conditions at H2.

An initial landing was attempted by 22H at Helispot 2 (H2) but due to brown-out conditions¹⁹ it had to be aborted and instead they land at Helispot 1(H1) a ½ mile air distance away. Both the helicopter manager and helicopter crewmember unload and make contact with RJ. The trauma kit and automated external defibrillator (AED) are unloaded and RJ and the helicopter crew member head down to the medical site via truck with additional oxygen. The helicopter manager loads back into 22H and lifts off from H1 to reposition at H2 after dust abatement was performed by responding resources.

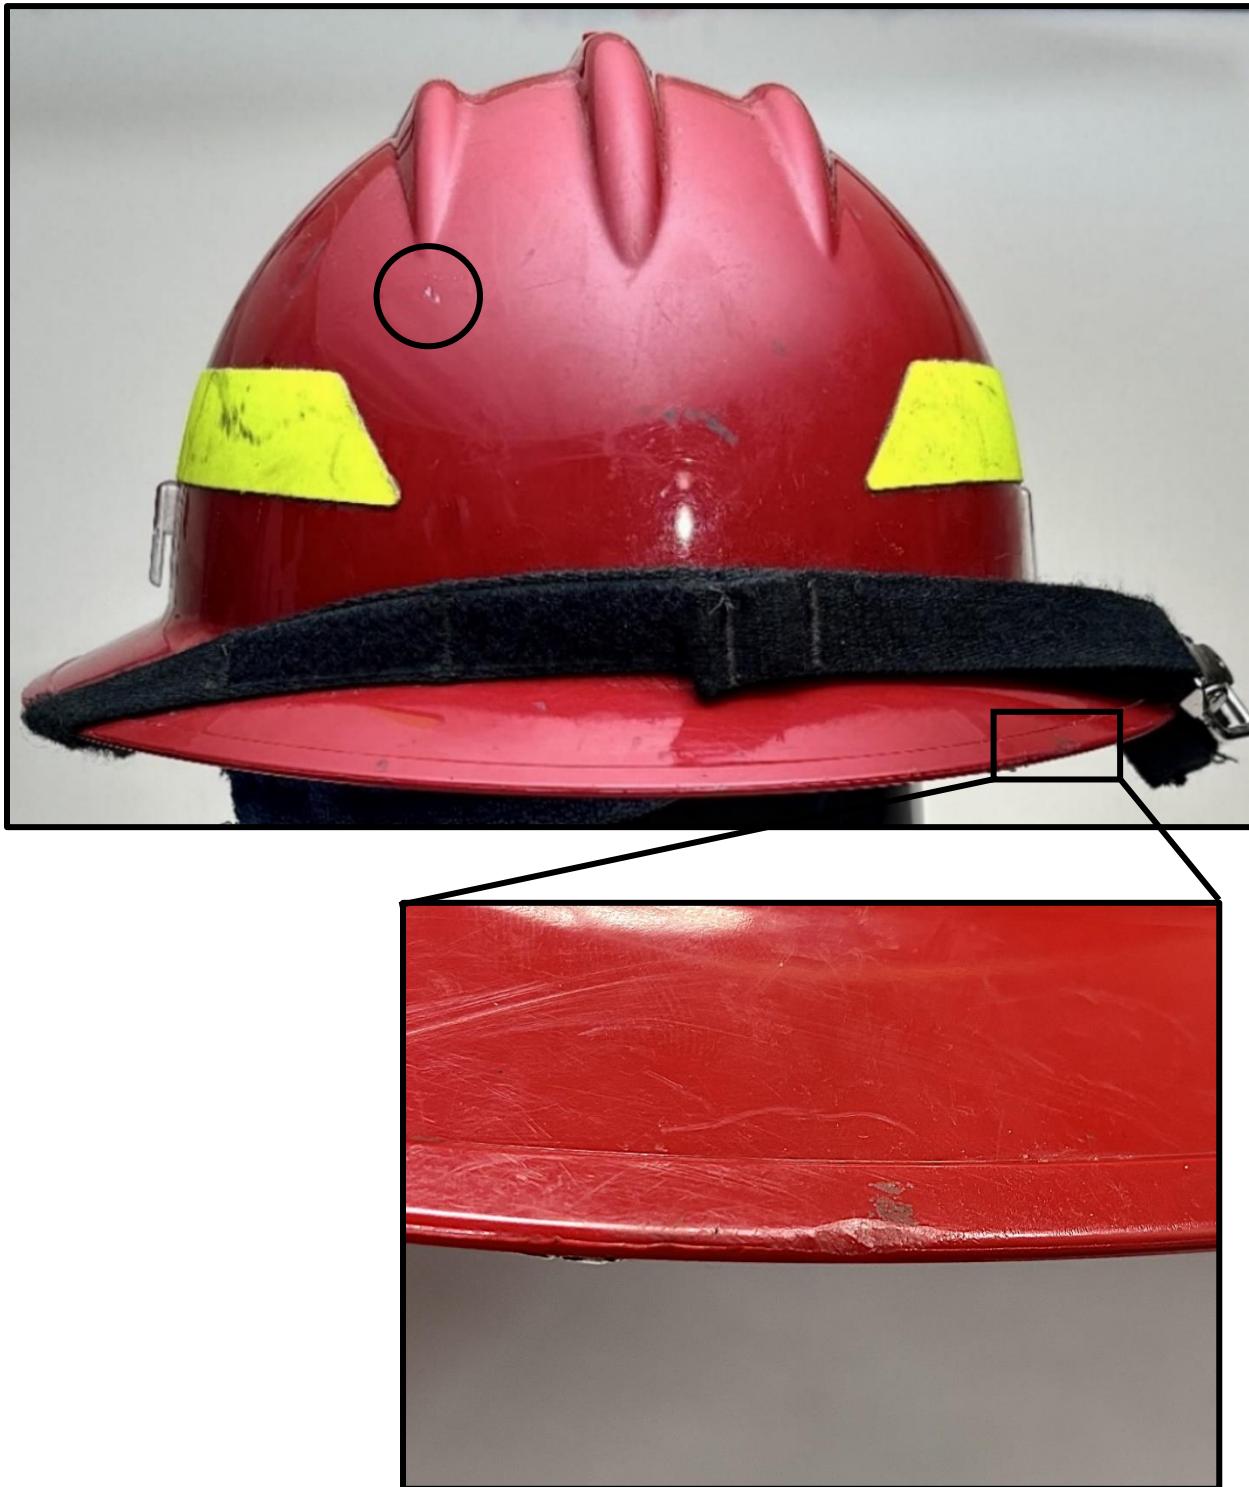
Figure 2: Helmet front showing white scratches (circle), dark scuffing, and brim indentation (box and inset image).

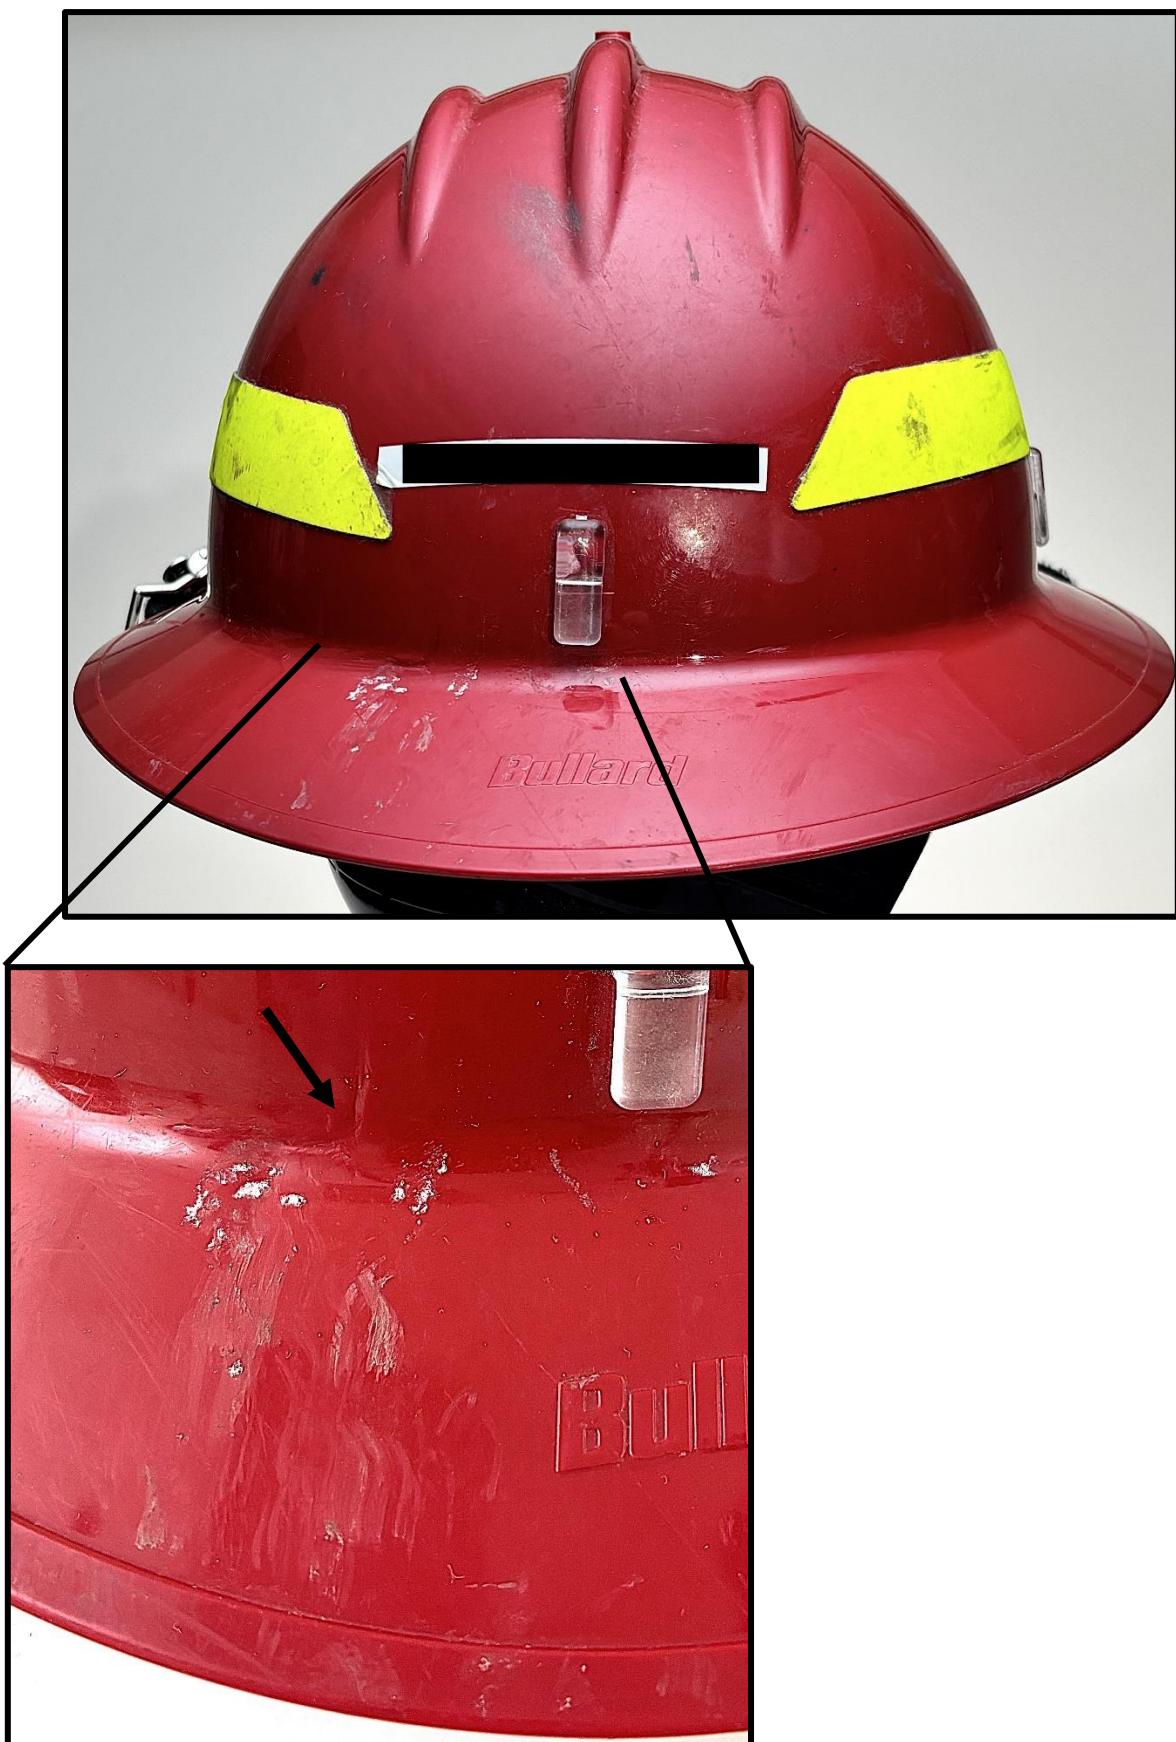
Rear-- Dark scuffs and smaller scuffs/scrapes present. Gouge in goggle clip with discoloration behind clip. Brim left center has white gouges, scratches, and indentations in helmet shell. Reverse L-shaped indentation in shell above brim/cap margin. Slight brim deformity and downward deflection left of center. See figure 3.

Figure 3: Rear aspect showing dark scuffing, scratching, white gouging, and indentations present. Arrow indicates reverse L-shaped indentation above the brim/cap margin.

These inspection findings indicate that the helmet received a significant lateral impact to the rear left-center aspect. A substantial amount of impact force is required to cause the damage found during the inspection of the helmet. The tree that struck the firefighter on the Tinker Bugs prescribed fire delivered impact energy exceeding the protective capabilities of the helmet.

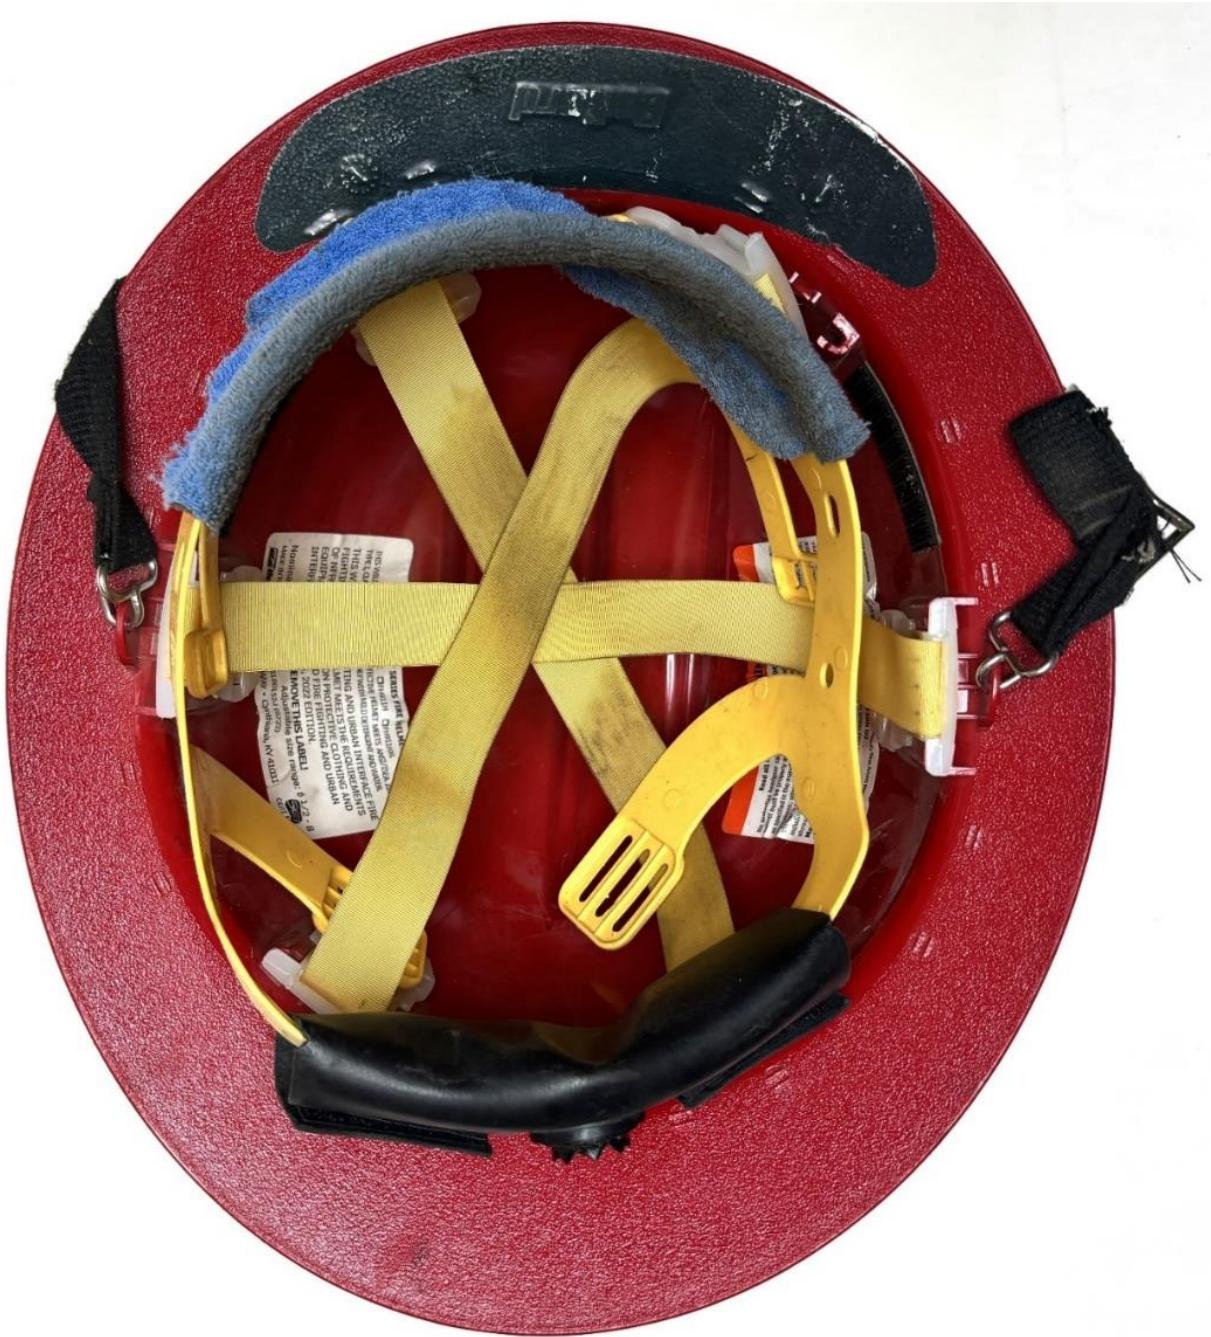
Released Keys—Left front suspension key released from the helmet key slot. See figure 4.

Figure 4: Helmet suspension as provided to NTDP.

Height Adjustment Slots Released from Key Peg—The left lateral, left rear, right lateral, and right front height adjustment slots were released from their key pegs. The right rear and left front height adjustment slot remained attached to their key pegs. However, the left front key was released from the helmet key slot. See figure 4.

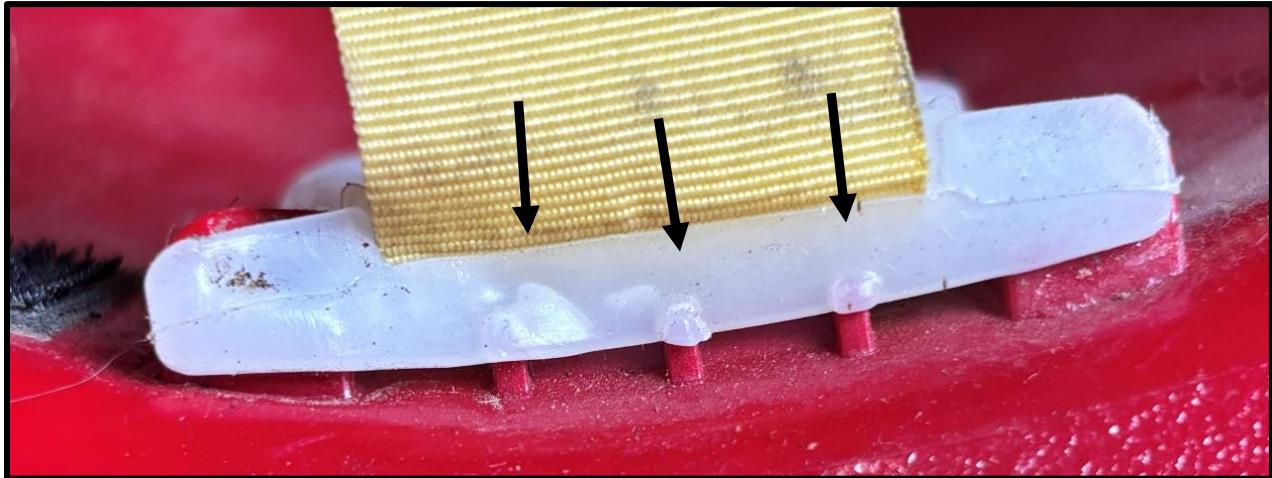
Damaged Keys—The left rear key was forced deeper into the key slot. This caused damage to the suspension key right ear and deformations and indentations to the key from the key slot. See figures 5 and 6.

Figure 5: Black arrows point to deformities and indentations where suspension key was forced deeper into key slot.

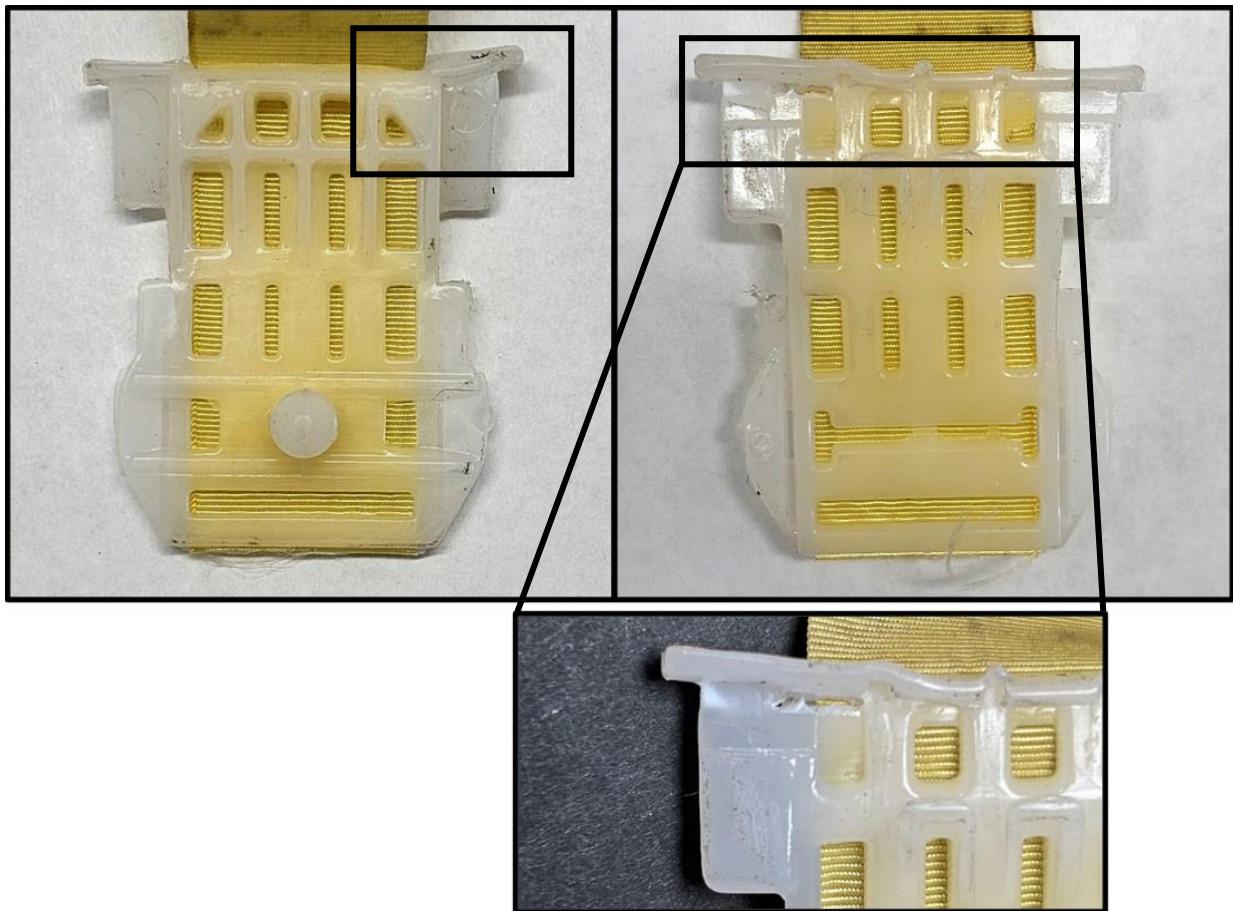
Figure 6: Front and back view of the rear left key. The left black box shows key ear deformation. The right black box indicates key damage and indentations. Inset image shows close up of tearing damage to key ear and hole created.

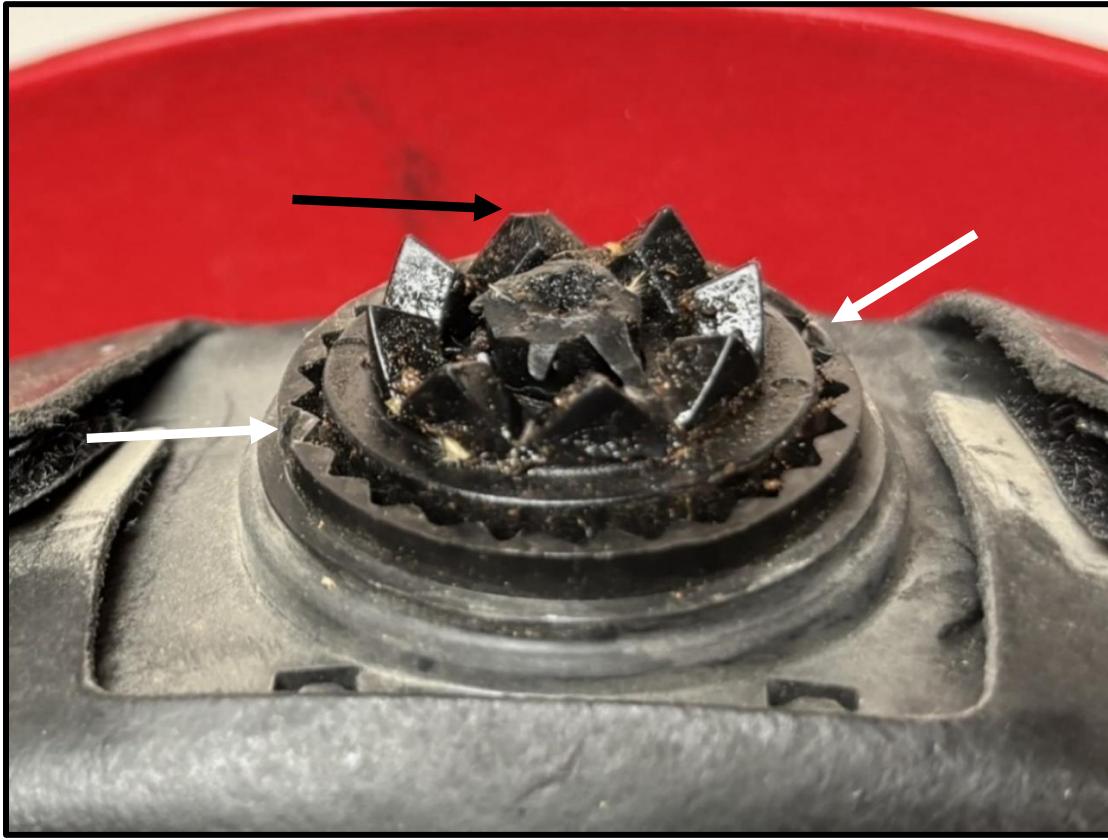
Adjustment Ratchet Knob—Broken free and not submitted for evaluation. The remaining ratchet mechanism has gouges present at nine and two o'clock, and one ratchet tooth, at twelve o'clock, has the tip broken off. See figure 7.

Figure 7: Showing missing ratchet knob, broken tooth (black arrow), and mechanism damage (white arrows).

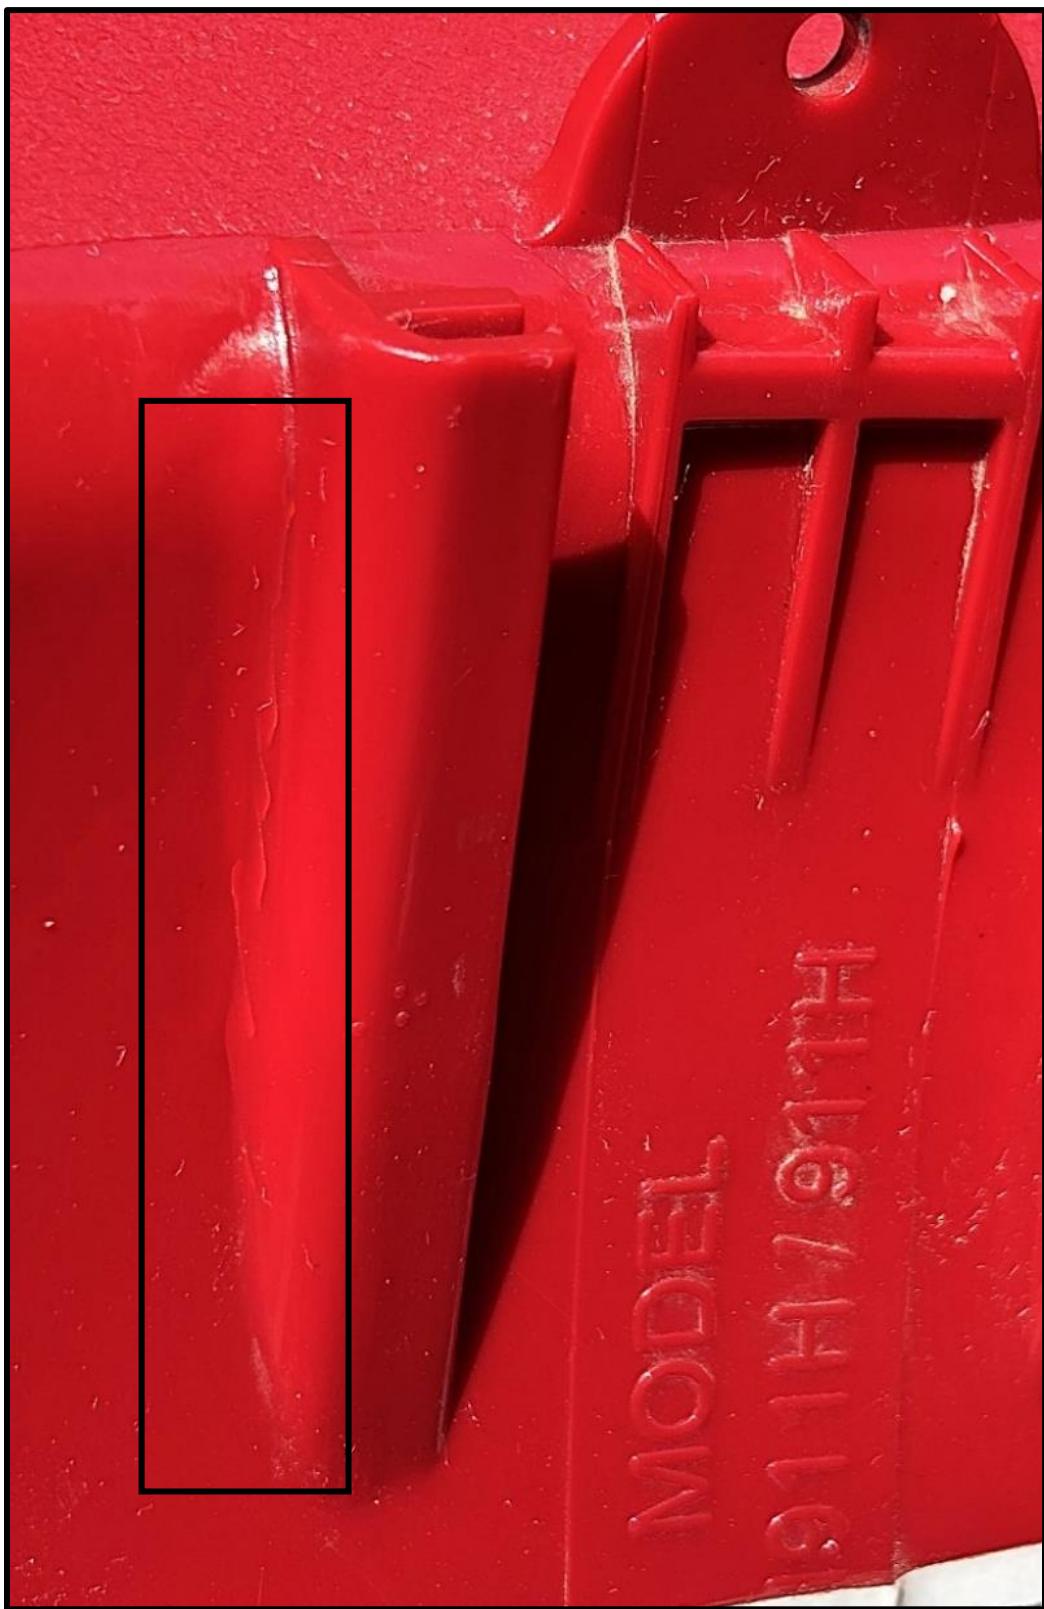
Right lateral key slot—Slight crazing present above the key slot. Crazing found along both sides where key slot attaches to helmet. See figure 8.

Figure 8: Right lateral key slot crazing where key slot attaches to helmet shell. Shown by rectangle.

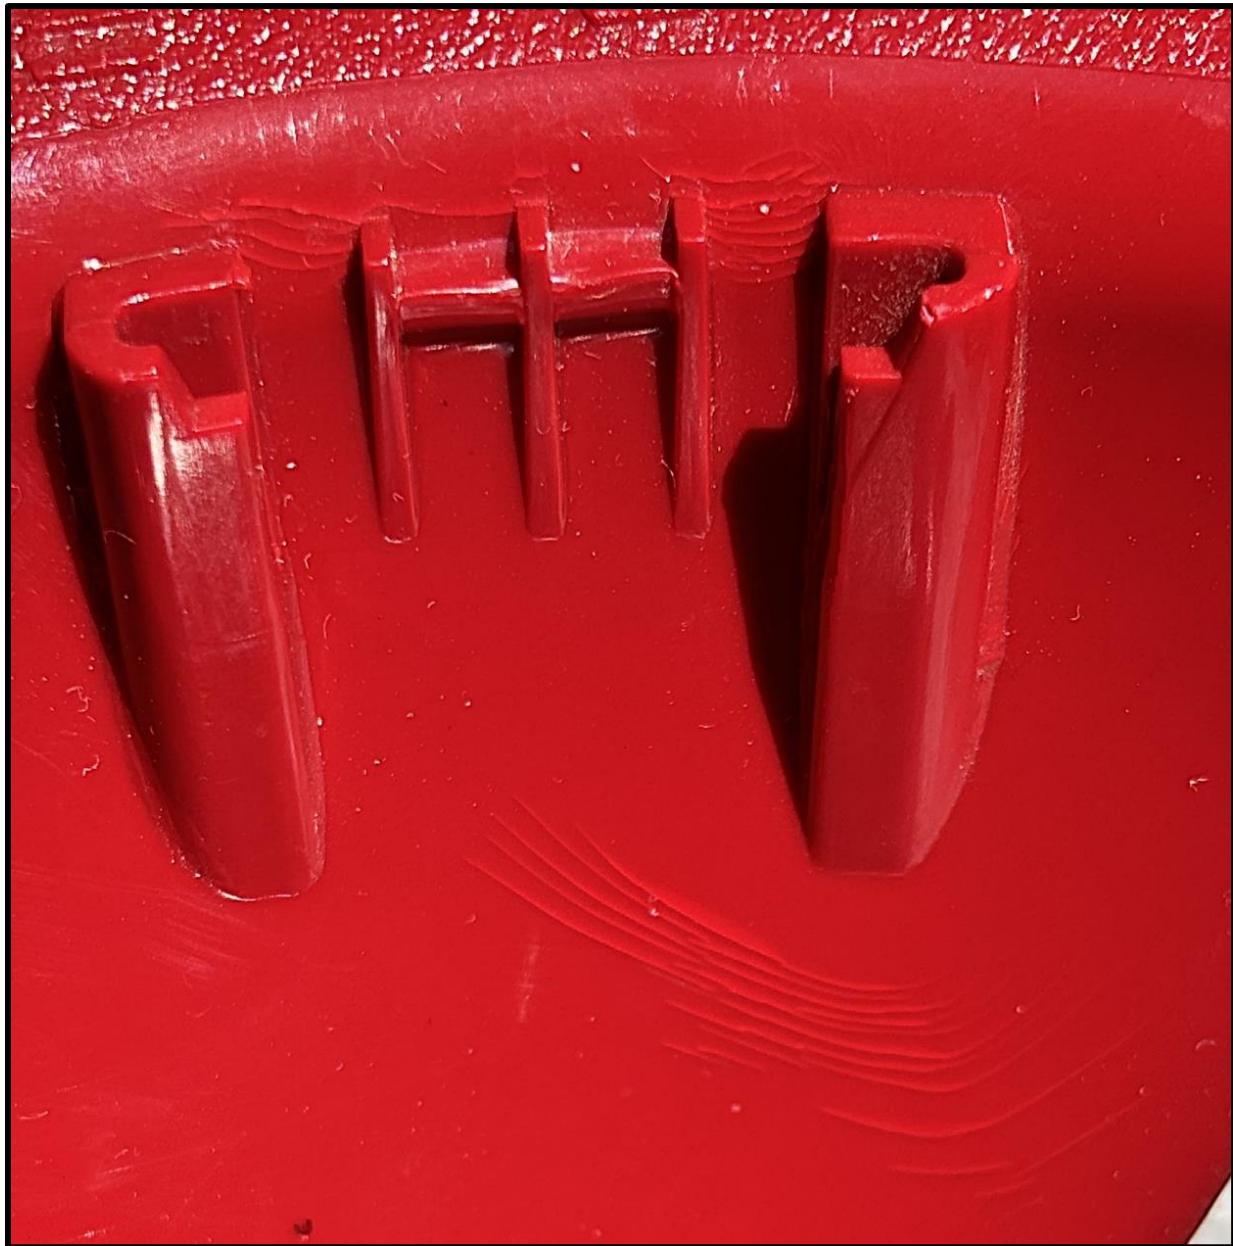
Right rear key slot—Crazing present above and below key slot. Crazing found along both sides where key slot attaches to helmet. See figure 9.

Figure 9: Crazing found above and below the right rear key slot.
