Serious Accident Investigation Tinker Bugs Prescribed Fire

September 26, 2025

Nez Perce-Clearwater National Forests

Tree Strike Fatality

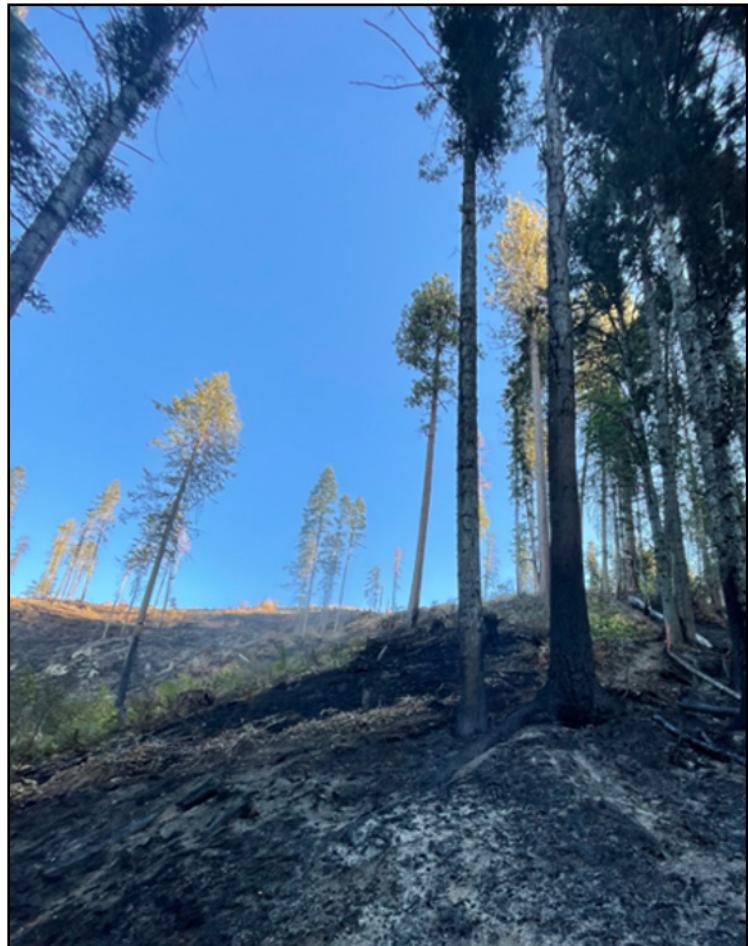
Figure 3.—View looking up the slope on Tinker Bugs Unit 12. This view captures the steep nature of the slope and burn conditions. Photo courtesy of Jason Brey.

The terrain on Tinker Bugs Unit 12 was incredibly steep and inhospitable to easy hiking with a slope greater than 60 percent. “It was a God-awful unit...”, “Super under slung⁸ burn” and “snags were everywhere and not feeling good for a prescribed burn,” stated resources on Unit 12 attempting to describe the challenging conditions on the ground.

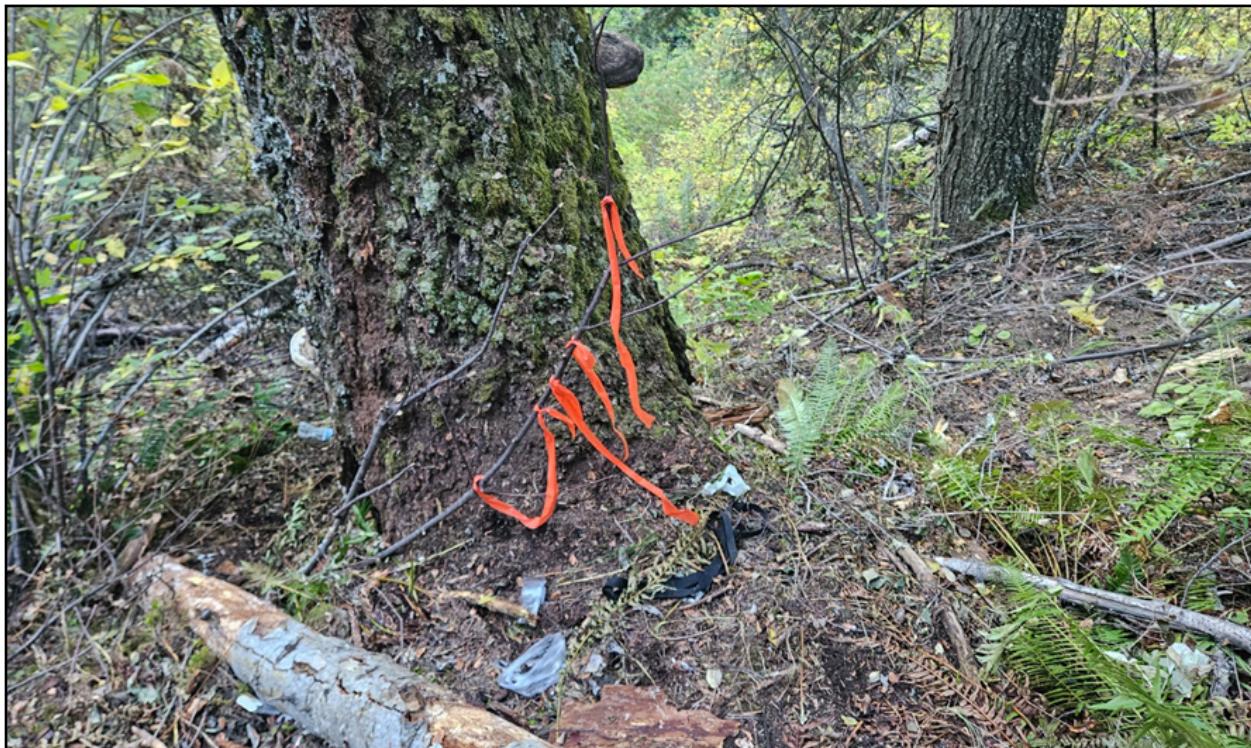
Figure 7.—Douglas-fir tree where Bella came to rest after rolling down the hill. Orange flagging indicates where she was found by EMTs. Photo courtesy of IDL Chris Lile.

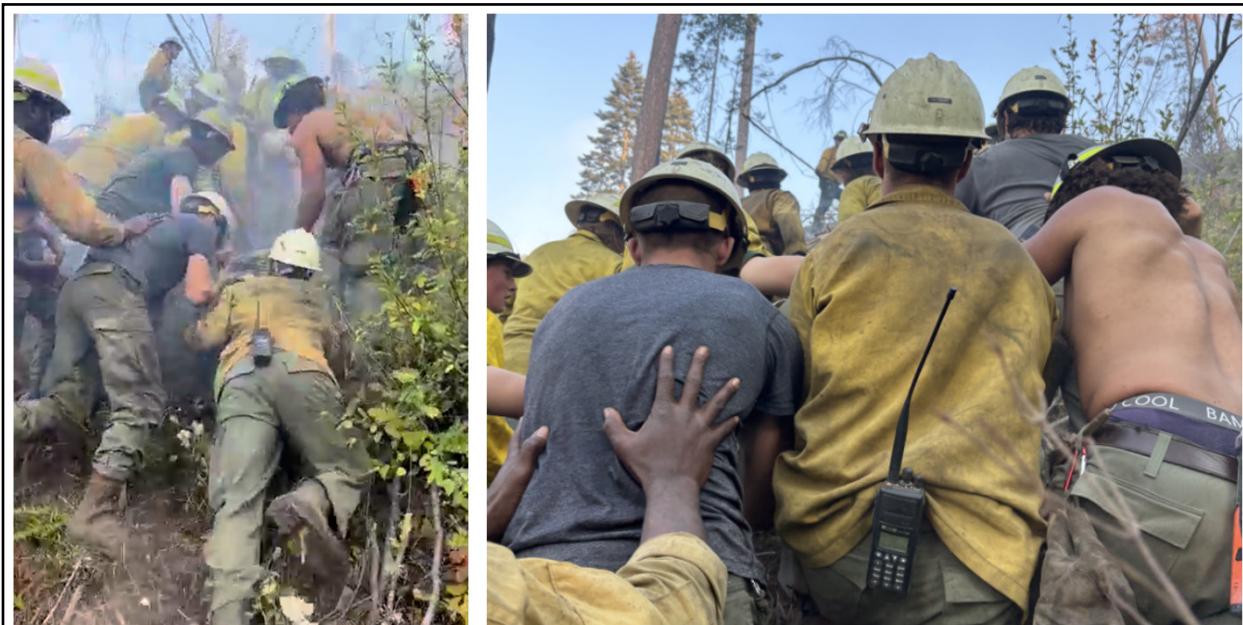
Figure 8.—Resources on scene moving Bella up the steep slope (60 percent slope) in the SKED. Note: individuals without yellow Nomex shirts removed their PPE in order to properly package Bella.

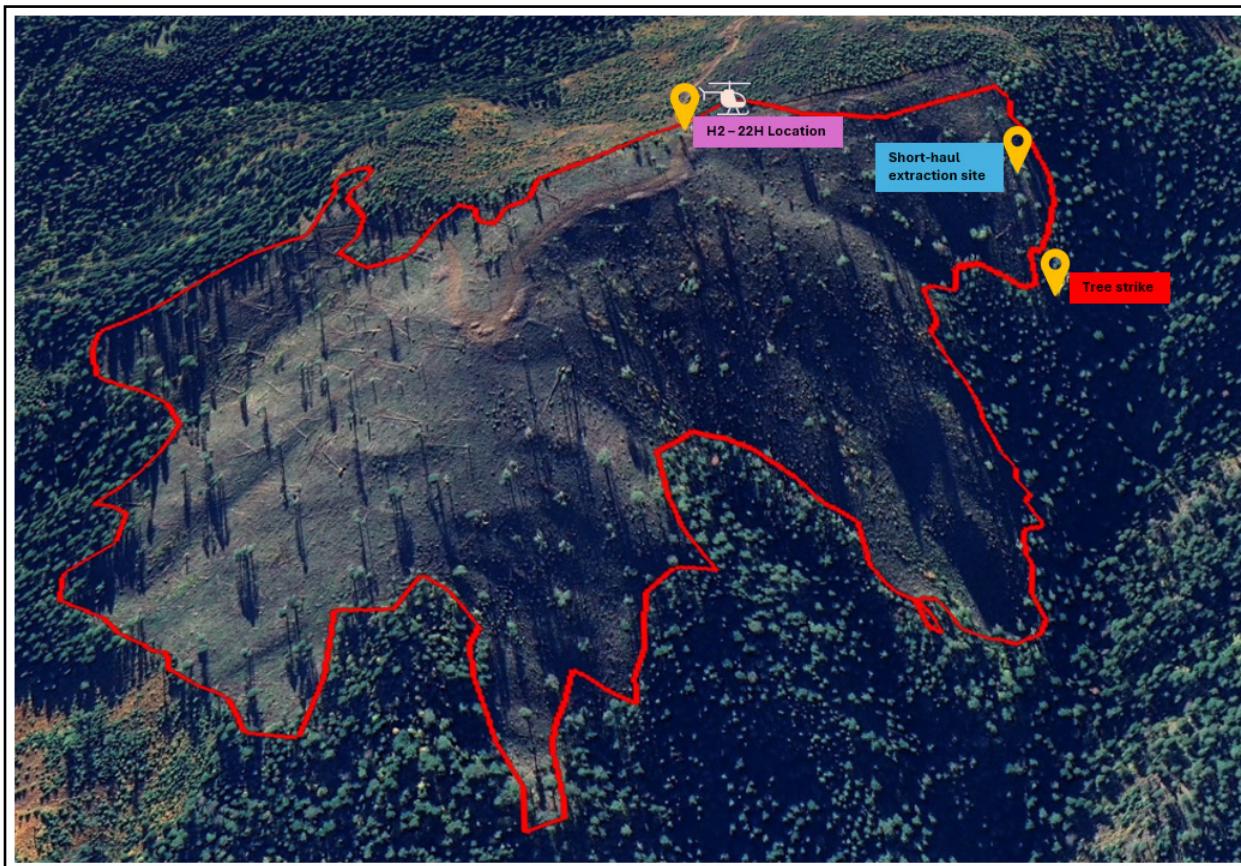
Figure 9.—Google Map image depicting the original Tinker Bugs 12 perimeter (red), the tree strike location, the Short-haul extraction site and H2 where 22H was located for patient transport. Oriented South.

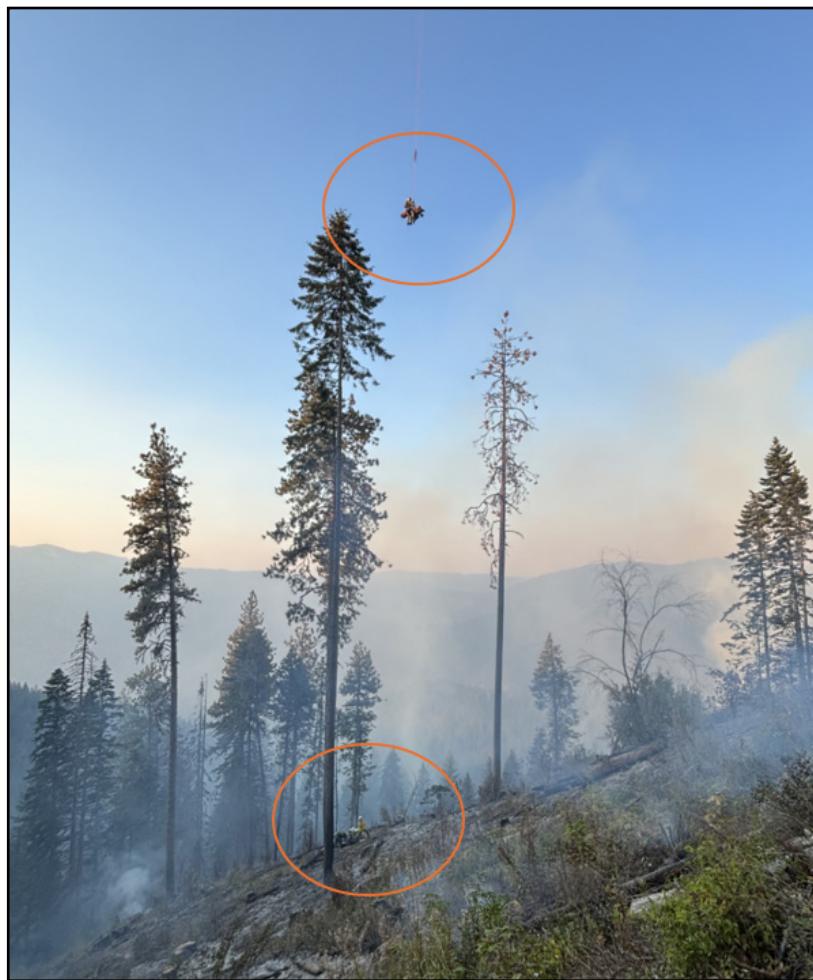
Figure 11.—Short-haul extraction site. Depicted is the Short-hauler coming in at the top of the photo and the small group of IWI personnel huddled at the extraction location.
